SEISMIC BEHAVIOUR OF MASONRY DOMES AND VAULTS HAGIA SOPHIA IN ISTANBUL AND ST. FRANCIS IN ASSISI

Giorgio CROCI¹

SUMMARY

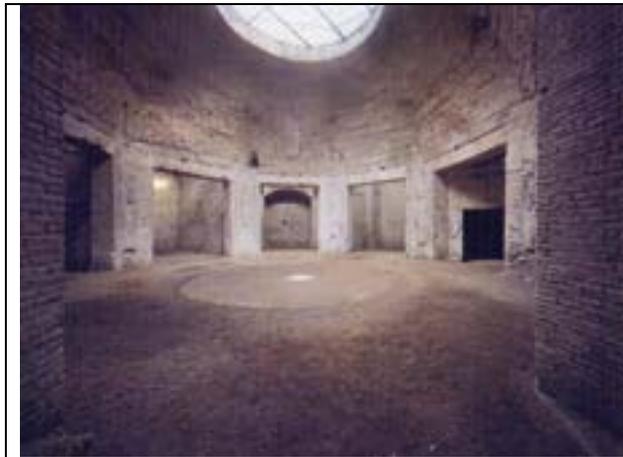
Fig. 1 – The octagon hall of the *Domus Aurea*

One of the first important works was carried out in the first century A.C., the octagonal hall in the Nero's Domus Aurea (Figure 1). It has influenced not only the Pantheon, one century afterward, but provided inspiration for Brunelleschi in solving the problem of the octagonal dome of St. Maria del Fiore, 1350 years later.

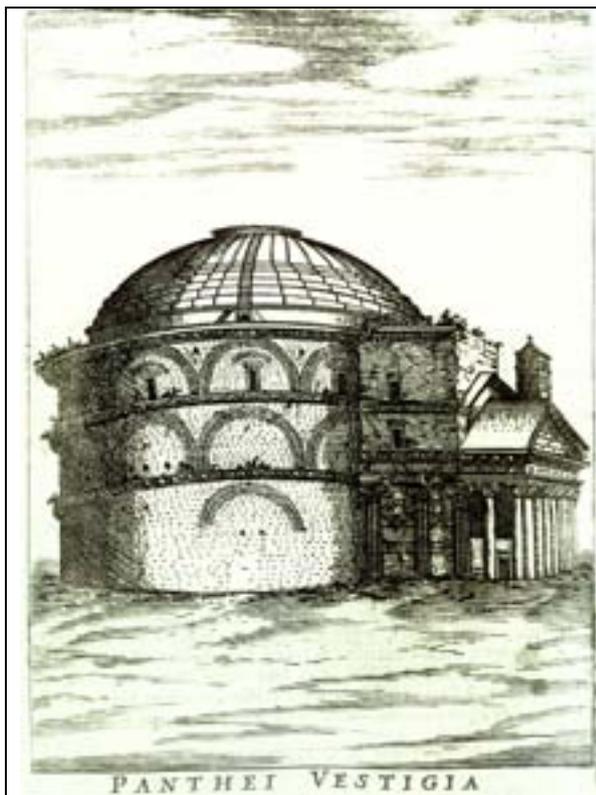
Fig. 3 – The “arches” visible on the extrados of the *Rotunda*

Concerning the cylinder, from outside it appears as a big brick wall, containing within its thickness a series of arches (visible on the external face – *Figure 3*) which inside correspond to niches and empty spaces (*Figure 4*).

These arches, which in reality are “false arches” built inside the masonry, are of particular interest as they show how the Romans preferred to utilise their large experience on arched structures (aqueducts, amphitheatres, etc.) rather than realise a huge continuous wall where it would have been more difficult to control the flow of forces, the influence of soil settlements during the construction, shrinkage and viscous phenomena.

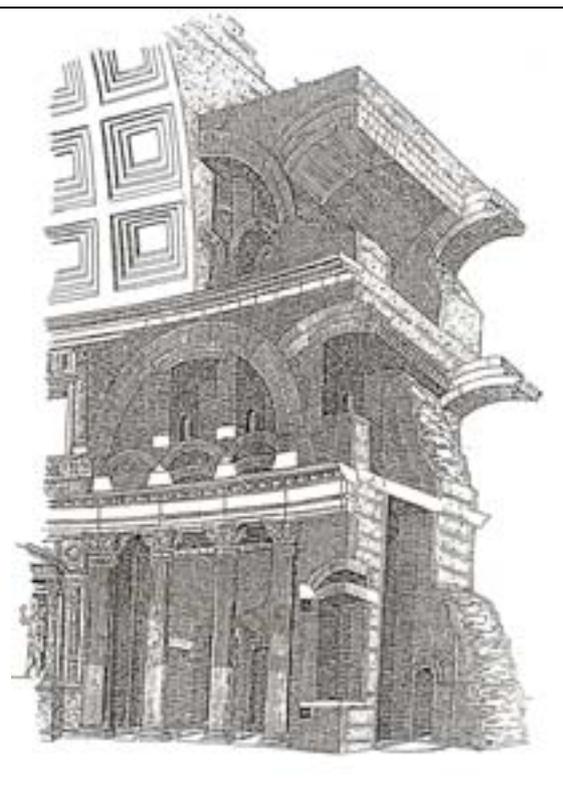
Fig. 4 – A section of the *Rotunda*

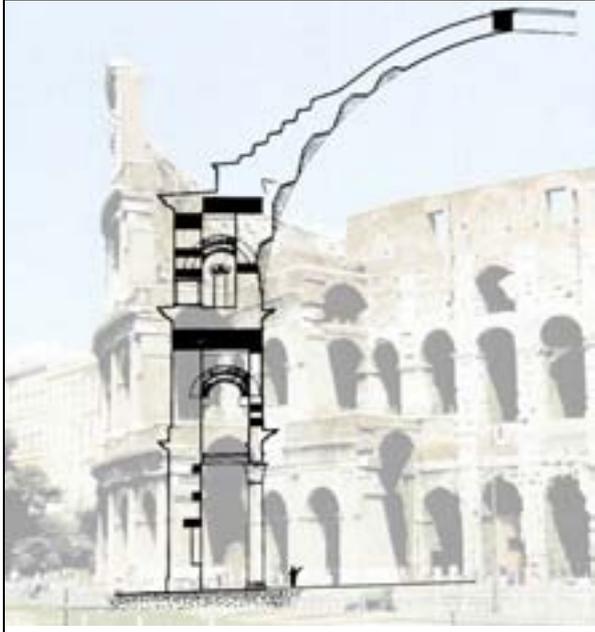
Fig. 5 – Photomontage of a section of the *Pantheon* over the *Colosseum*

Probably the builders of the Pantheon were influenced by the Colosseum which, even if it appears completely different in its structure, in reality it is much similar to the Rotonda than would be expected. The photomontage of (*Figure 5*) gives an idea of that.

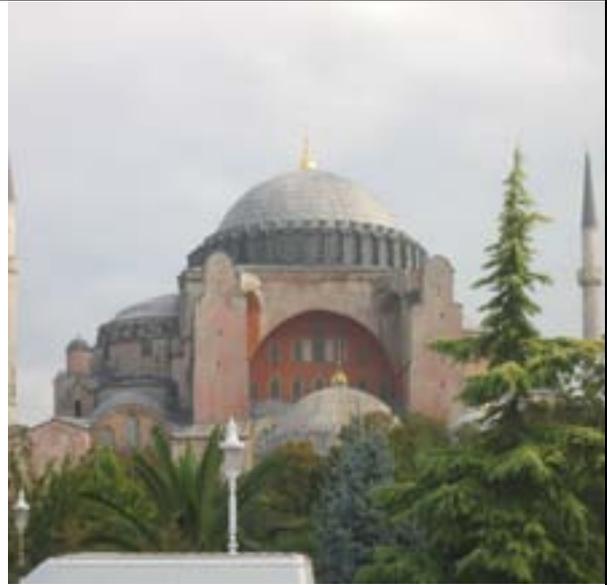
Fig. 6 – *Hagia Sophia*

Hagia Sophia (built in the present shape under the Emperor Giustiniano in the 6th century – *Figure 6*) cronologically is the second biggest dome in the history of architecture and received its inspiration from the Pantheon. However, Hagia Sophia features some important differences related to the fact that the dome is supported by four huge pillars placed on the corners of an ideal square base. This creates two problems:

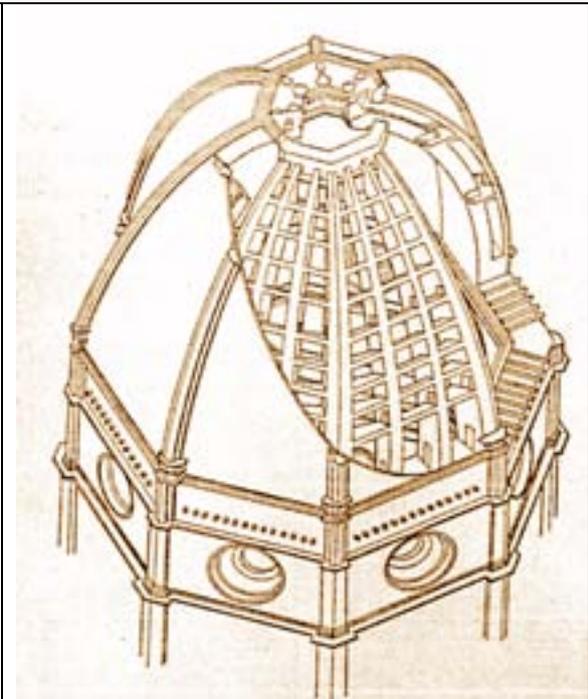
Fig. 8 – The ribs which form the body of the Cupola of *St. Mary*

The dome of the Church of St. Mary of the Flower (Brunelleschi, 15th century – *Figure 7*) is the first example of a big dome with a double shell on an octagonal plan. The dome, whose diameter (43 m) is similar to the Pantheon, received its inspiration from the Gothic vaults: in order to reduce the thrust the shape is ogival and, to reduce the weight the main bearing structure is made of 8 principal ribs (or spurs) in the corners and 16 supplementary ribs in the middle of the webs (or segments of the shells). The circumferential connection is ensured by 4 stone ribs (a kind of “chains of stone” reinforced with steel clamps) and a wooden chain; in addition small horizontal arches improve the connection between the corner ribs and the adjacent ribs on the webs (*Figure 8*).

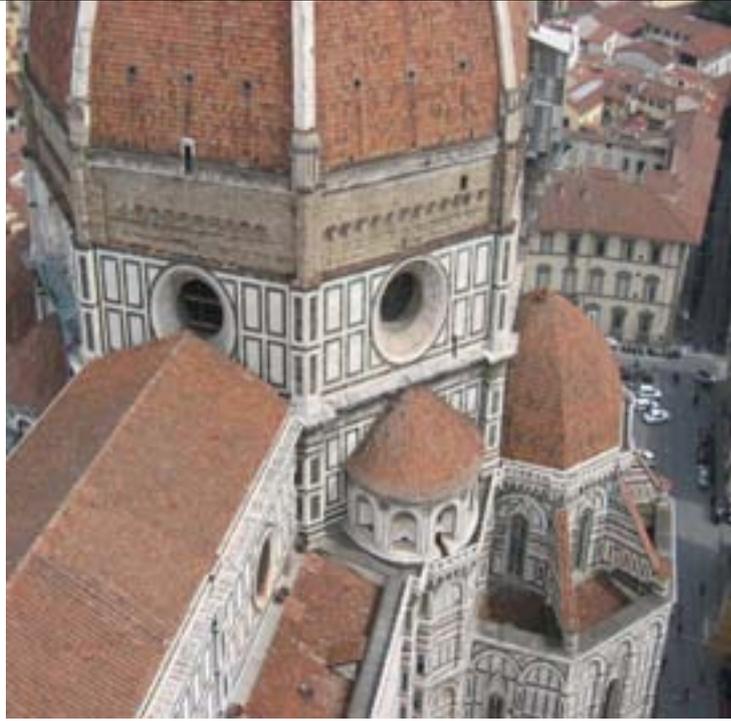
Fig. 9 – Small hemidomes which stabilise the structure of *St. Mary*

The octagonal base of the dome is made of four huge pillars on four sides and four arches in between so that the supporting structure is stiff, and stiffened more by the connection with small hemidomes, probably inspired by Hagia Sophia (*Figure 9*).

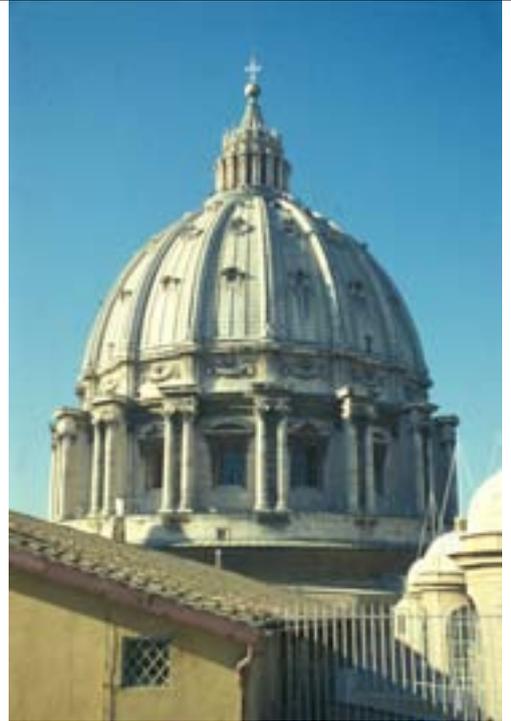
Fig. 10 – *St. Peter*

The dome of St. Peter (Michelangelo 16th century – *Figure 10*) has a diameter similar to the Pantheon and S. Maria del Fiore (43 m) and, as the last, has deeply been influenced by the Gothic conception. Nevertheless there is a general harmony and classical inspiration is evident.

The project of the St. Peter’s dome has had several vicissitudes before arriving at the final design of Michelangelo. A significant difference between the domes of Brunelleschi and Michelangelo is in the shape of the drum, that here is circular, even if the dome is made with 16 ribs. The circumferential stone chains of S.Maria del Fiore, in St. Peter are replaced with steel chains.

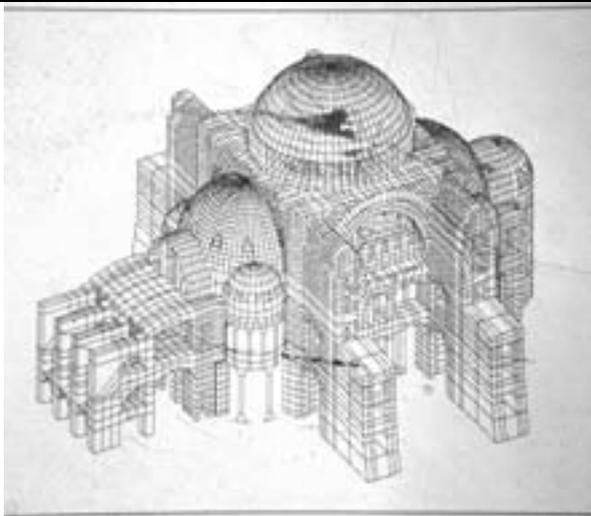
Fig. 11 – Axonometric mesh of the structure of *Hagia Sophia* (Federico Croci)

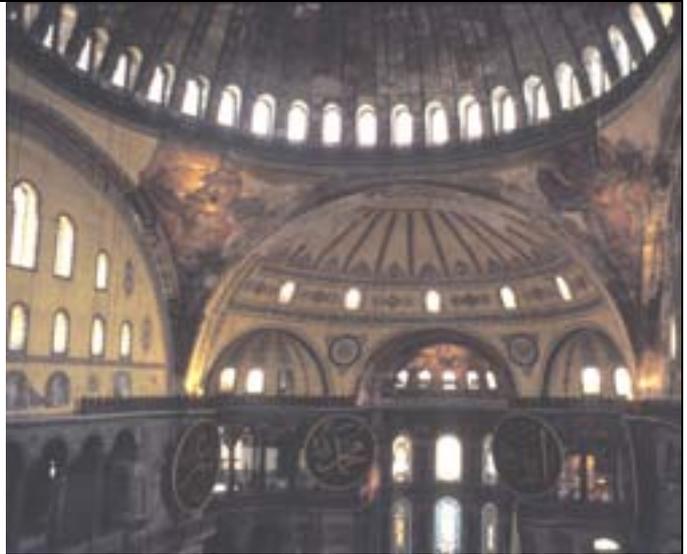
Fig. 12 – The dome, the pendentives and the arches which support the dome

The main dome rises to a height of 54 metres on a circular base, supported by four pendentives and four large arches which stand at the corners of the square bases (*Figures 12, 13*). The diameter of the hypothetical sphere, which includes both the dome and the pendentives (the diagonal of the base square), is about 43 metres, comparable to the diameter of the Pantheon dome which was used as a reference model by the Byzantine architects.

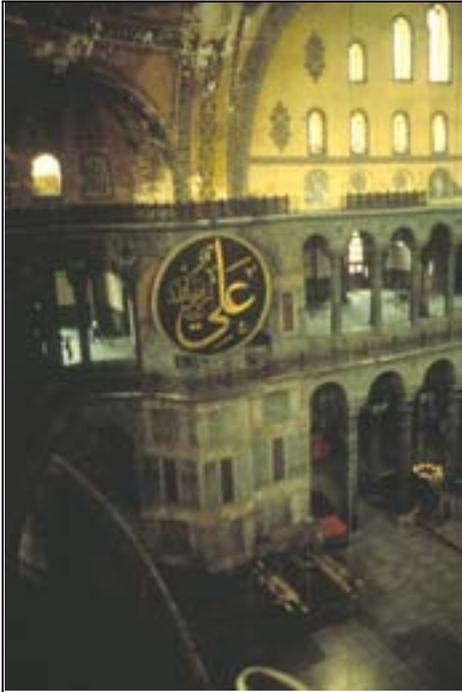
Fig. 13 – One of the four pillars which support the four arches

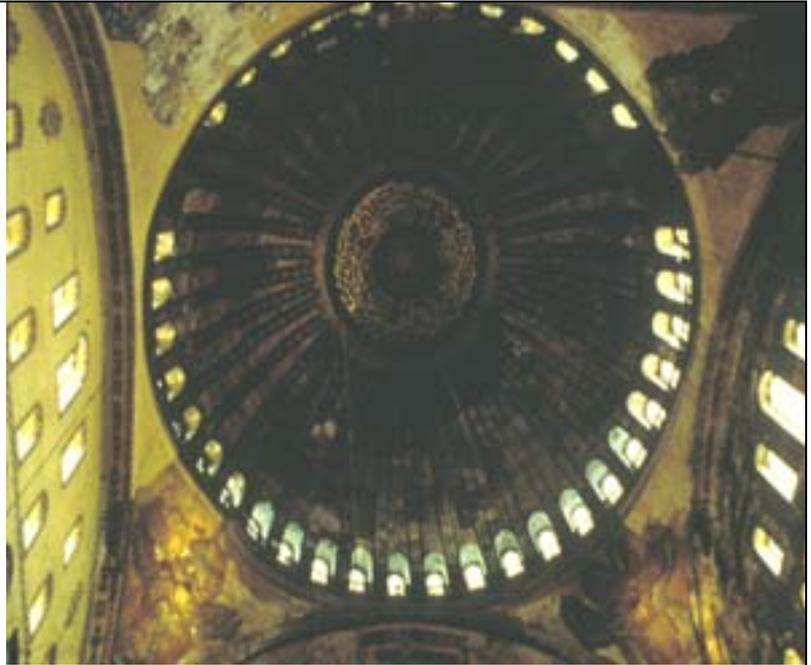
Fig. 14 – the base of the dome

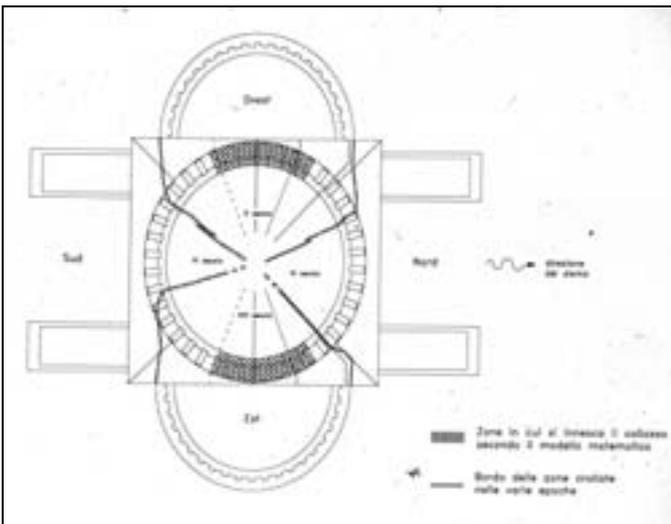
Fig. 15 – Position of the discontinuity lines which separate the original dome (VI century) from the portions rebuilt in the X and XIV centuries

At the present time, the dome shows four lines of discontinuity following to the meridians which constitute the limiting points between the dissimilar parts reconstructed at different times (*Figures 14 and 15*). The North and South parts show two segments of what was once the 6th century dome. On the West and East, interrupting the continuity of the first reconstruction more or less symmetrically, we can see the parts reconstructed in the 10th and 14th centuries respectively, whose area (similar in shape and size) is almost double that of the two parts remaining from the 6th century.

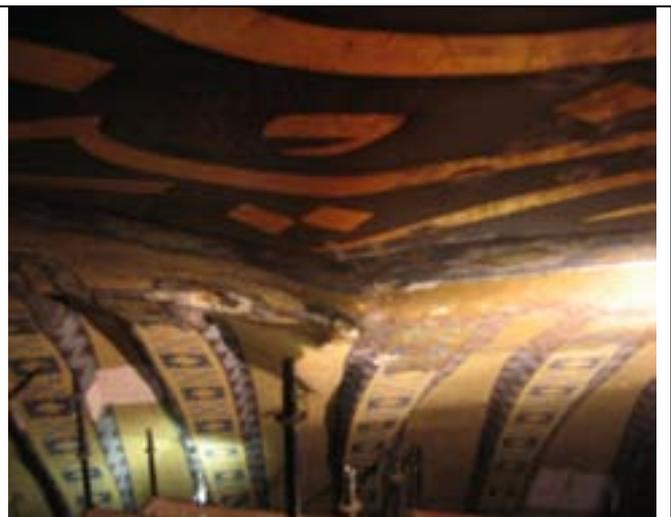
Fig. 16 – One of the discontinuity lines in the junctions between the original and rebuilt portions of the dome

We can also see irregular points and lines of discontinuity in the curvature of the dome, the arches and the pendentives. This discontinuity reflects the junction lines between the parts which survived collapse (now permanently deformed) and the reconstructed parts, where it was evidently impossible to maintain continuity of the tangents which would have meant repairing the existing deformation, or altering the newly reconstructed geometry (*Figure 16*).

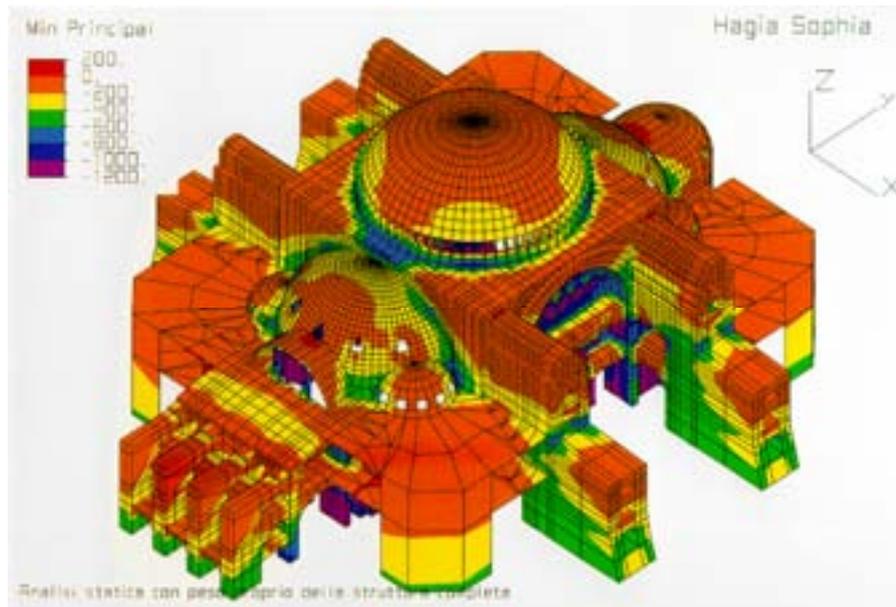
Fig. 17 - Static analysis considering only the building's weight. Main compression stresses

The static analysis, taking into account only the weight of each section of the overall structure, has shown that the stresses remain at low levels (*Figure 17*).

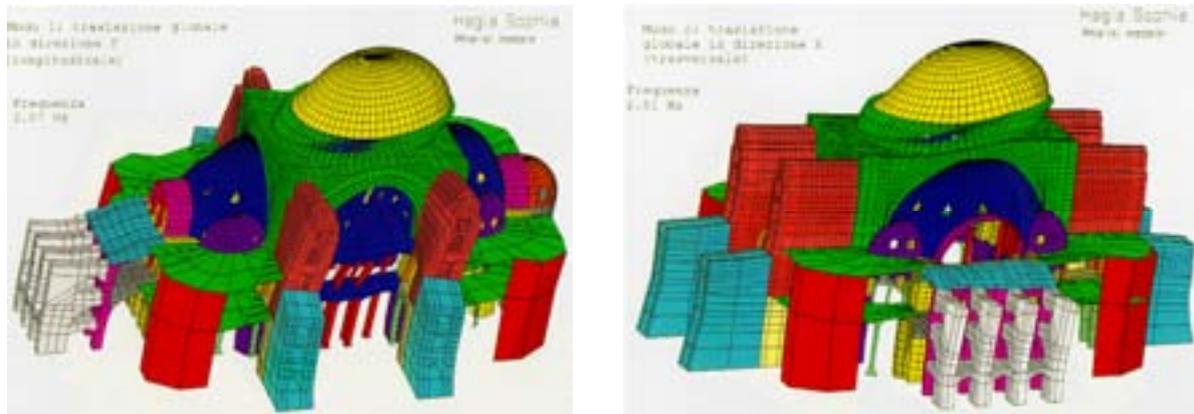
Fig. 18 – The first two vibration modes

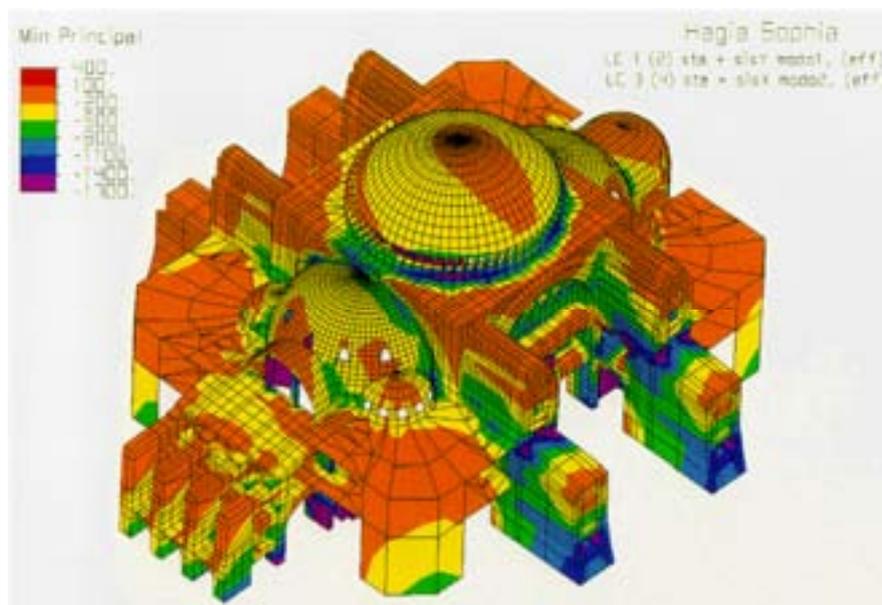
Fig. 19 – Compression stresses produced by an earthquake on the “abutments” directions

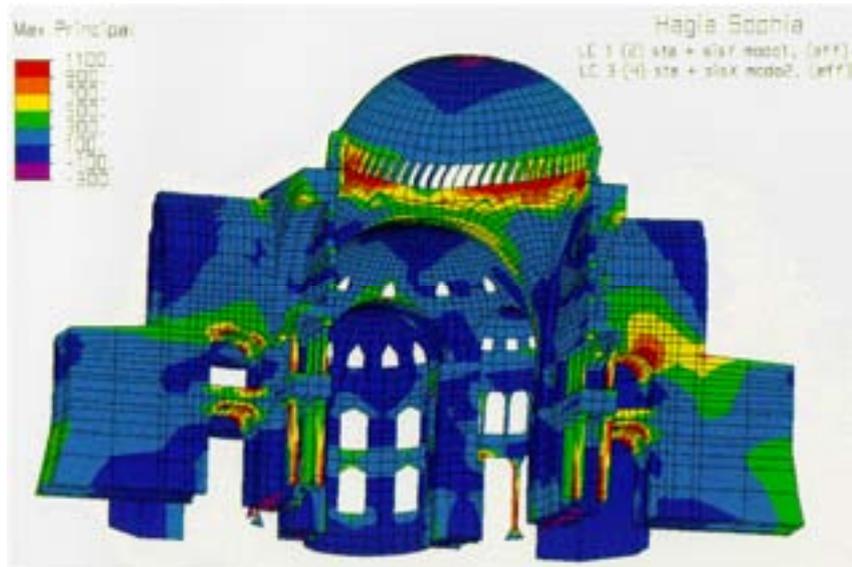
Fig. 20 – Tension stresses produced by an earthquake on the “abutements” directions

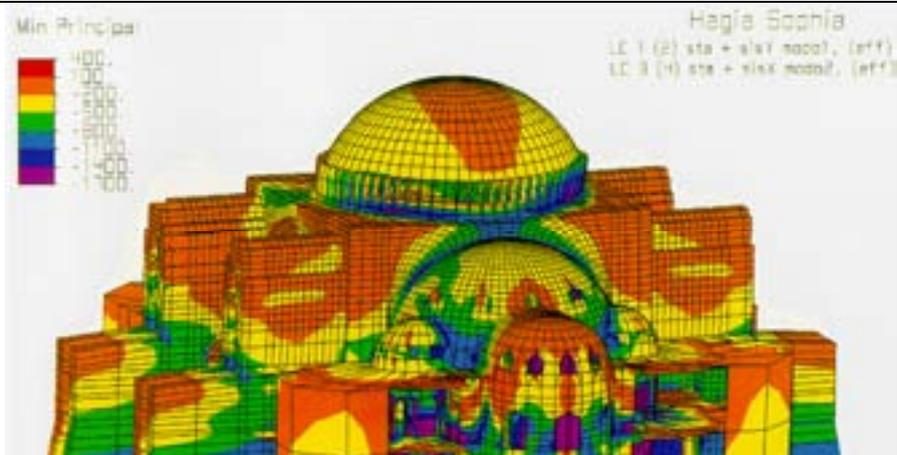
Fig. 21 – Compression stresses produced by an earthquake on the “hemidomes” directions

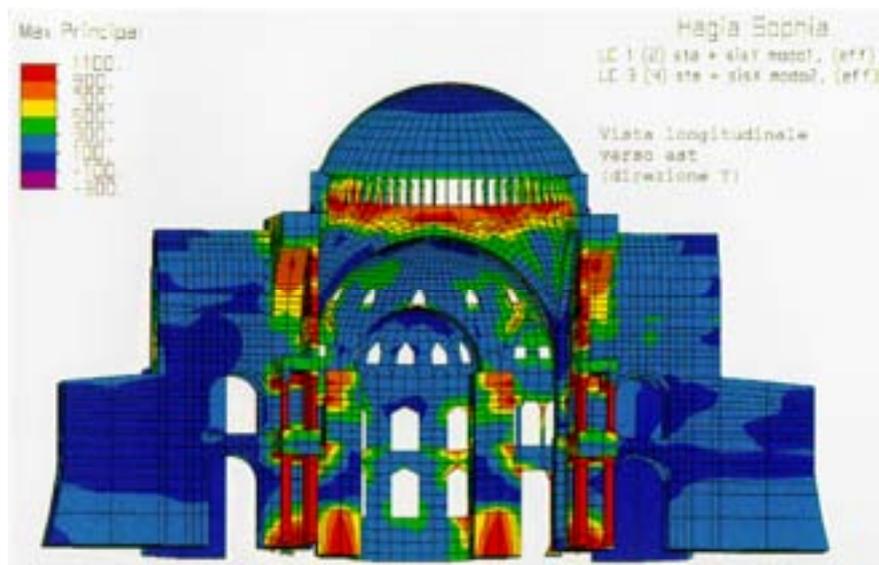
Fig. 22 – Tension stresses produced by an earthquake on the “hemidomes” directions

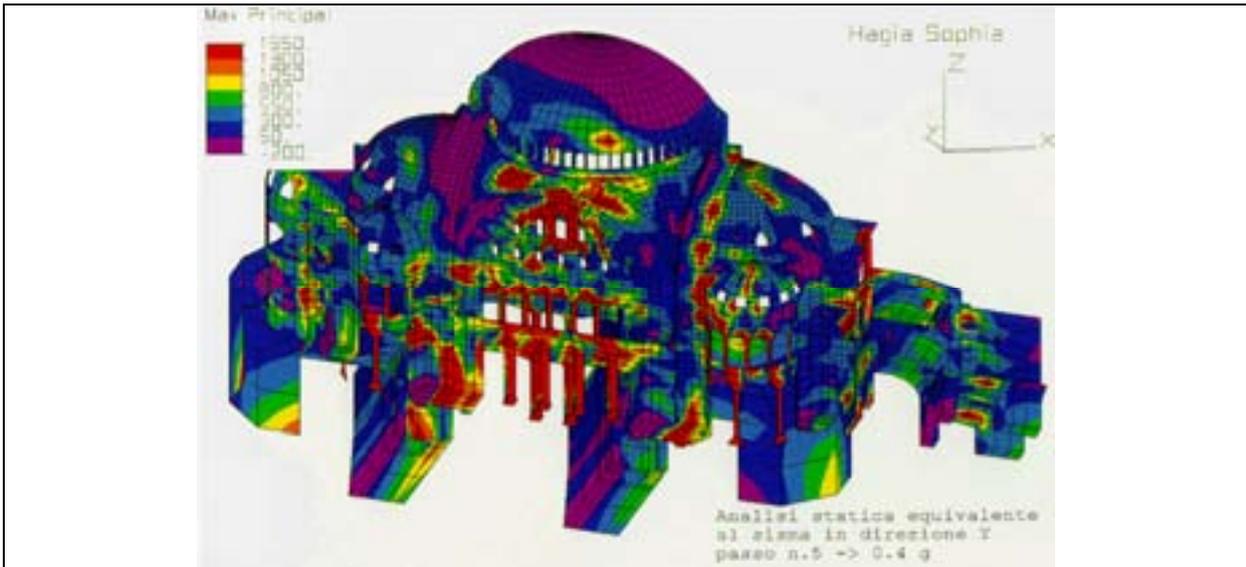
Fig. 23 – Step analysis. Tension stresses produced by an earthquake on the direction of the hemidomes

It is interesting to note damage produced in the model simulating the structural behaviour of the dome during an earthquake in direction of the hemidome well represents the situation that actually happened when the structure collapsed in the 10th and 14th centuries.

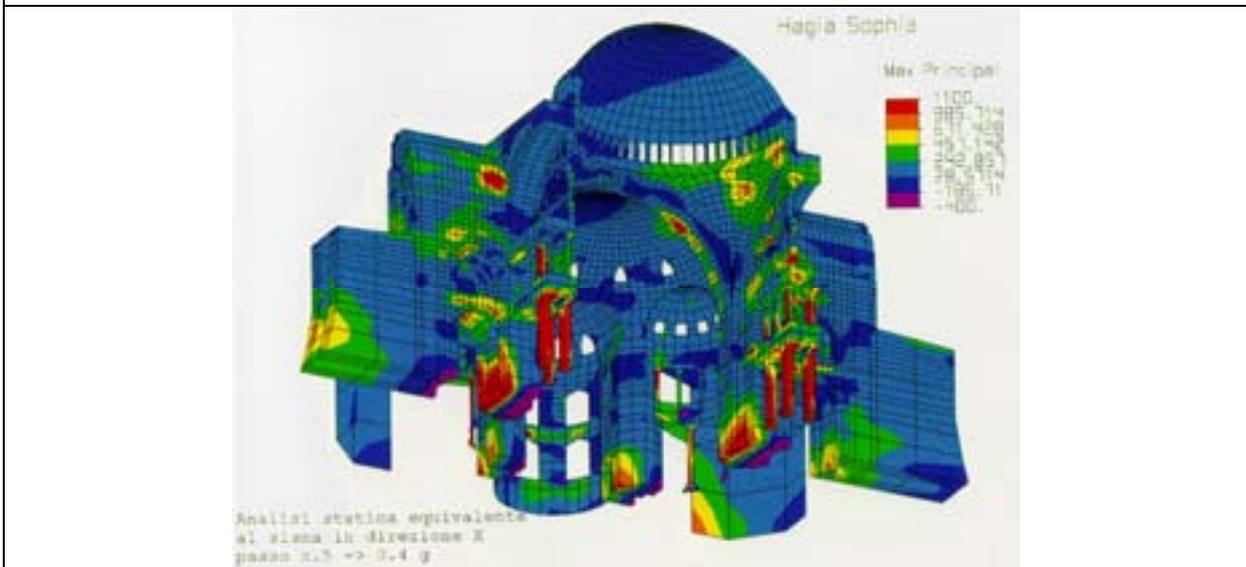
Fig. 24 – Step analysis. Tension stresses produced by an earthquake on the direction of the abutments

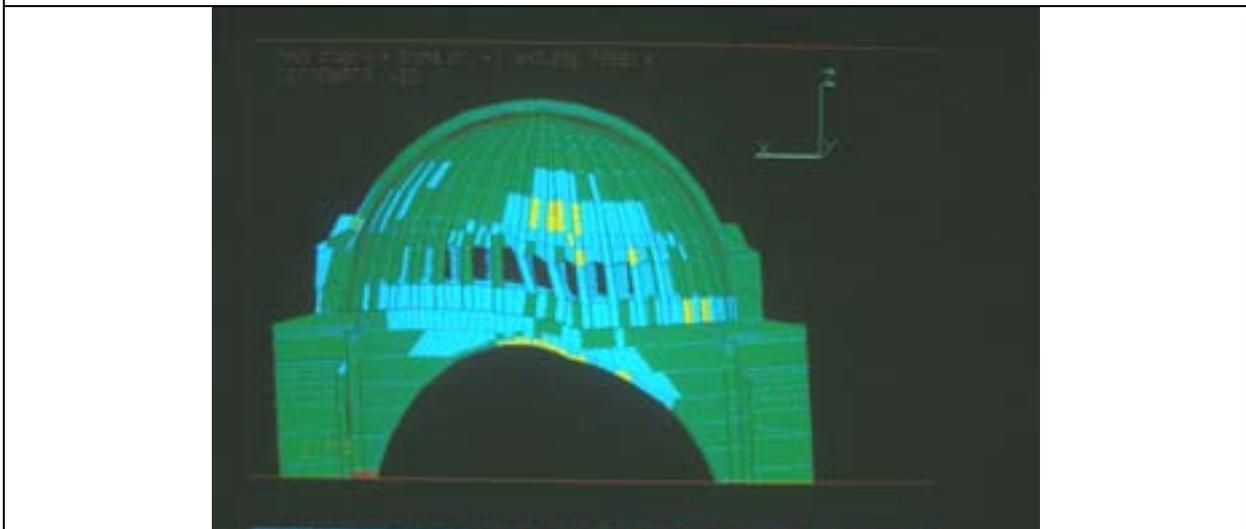
Fig. 25 – Collapse of the arch and the dome due to an earthquake in the direction of the abutments

The sequence of increasing forces highlights the fact that the collapse of the arch only takes place after the collapse of the tympanum which therefore, as already said, acts as an “abutment” element giving the structure more stiffness. However, it is important to emphasise that the distribution of damage and the deformations provided by the mathematical models are in no way comparable to the situation which can be seen today and to the shape of the collapses which occurred in the 10th and 14th centuries. Instead a good correspondence between theory and reality is shown when we analyse the structural behaviour under the effect of an earthquake which acts in the transversal direction X (*Figure 24*); in this case a concentration of tension is produced in the pendentives and the supporting arch of the dome which, not stiffened by the presence of a tympanum, is subjected to strong deformations. These deformations may loosen or even invert the curvature at the key of the arch and therefore result in collapse, as it is clearly visible from the detailed model shown in *Figure 25*.

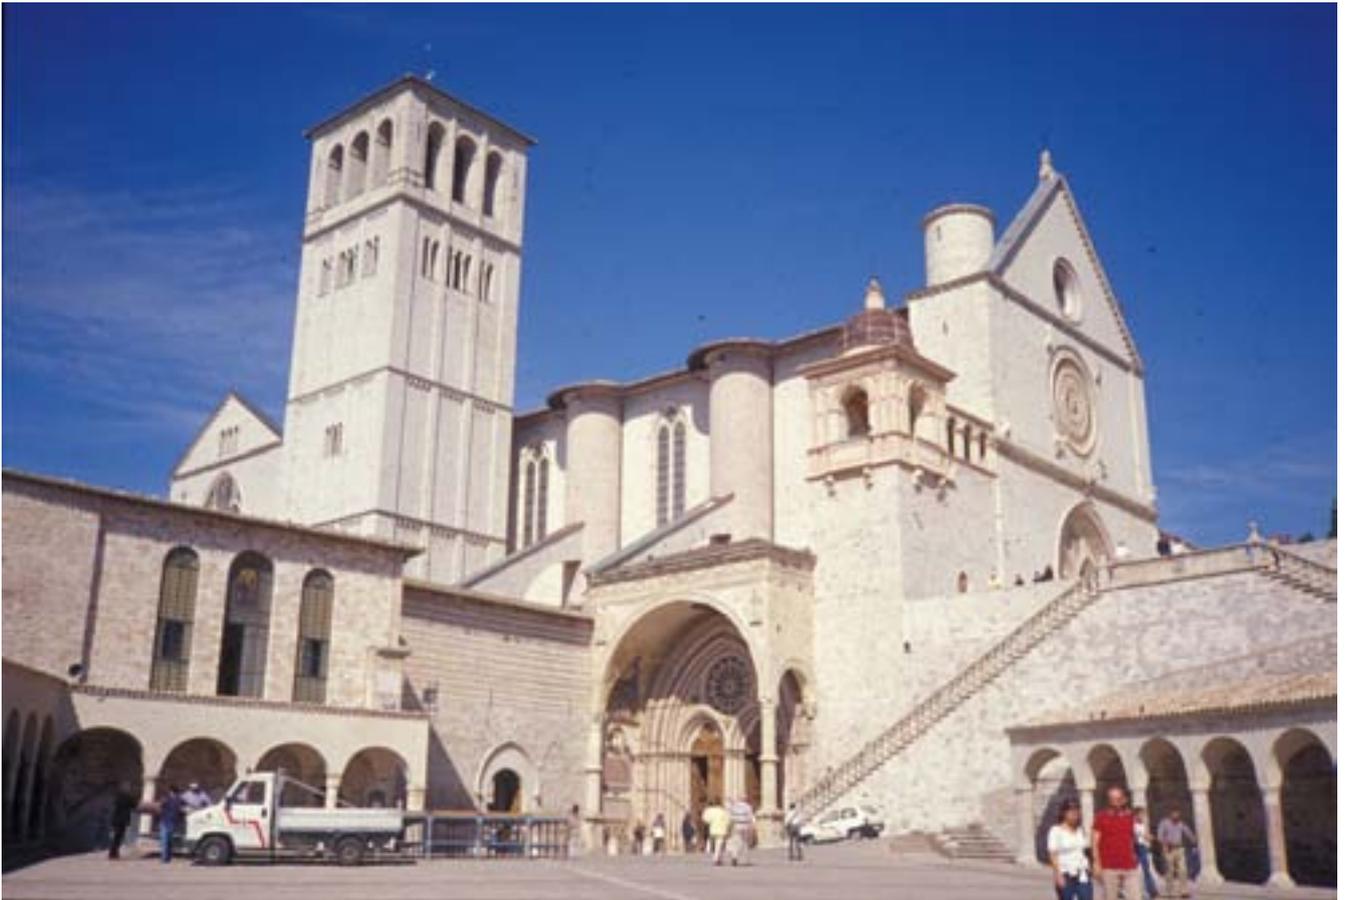
Fig. 26 - The Basilica of St. Francis of Assisi

In its history many earthquakes have hit the Basilica of St Francis (*Figure 26*), which was built in the 13th century. Important earthquakes occurred in 1279, 1328, 1703, 1747, 1781, 1799, 1832, 1859, 1917, 1979, and yet none produced damage as great as that which hit central Italy during the night of September 26, 1997, as well as the second that struck the Basilica at 11,42 a.m. The result was the destruction of the vaults close to the façade, of those close to the transept, of a portion of the left transept (*Figure 27*) and the production of large cracks and permanent deformation all over the vaults of the Basilica, leaving them in a very precarious and dangerous condition.

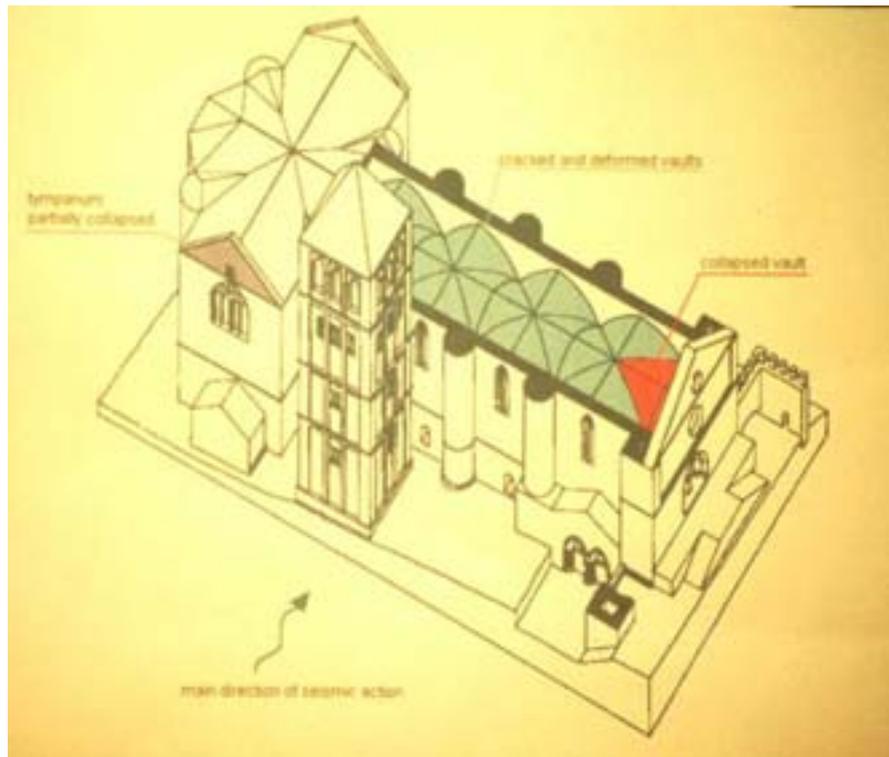
Figure 27 : The collapsed vaults (one is hidden behind the bell tower) and the damaged tympanum in the Basilica of St. Francis of Assisi

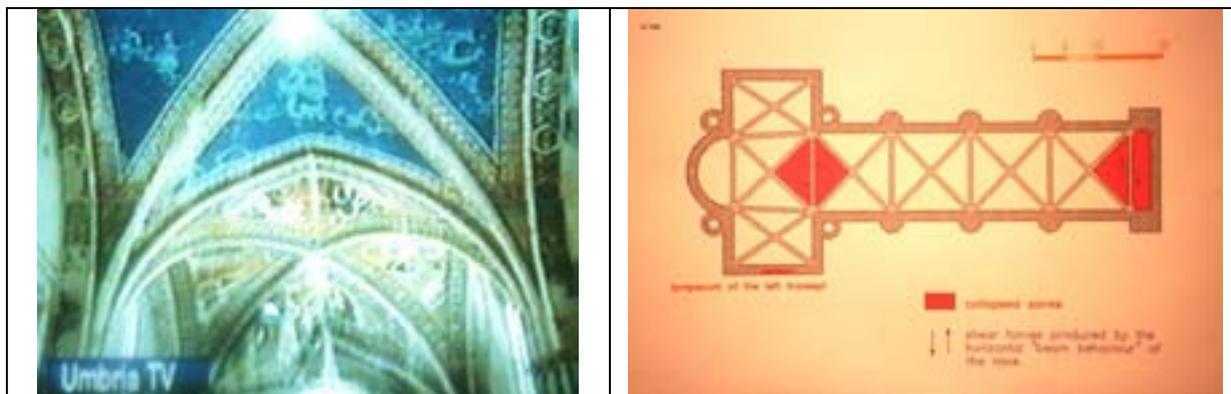
Figure 28 : A hinge is formed in a rib of the vault (Umbria TV)

The failure mechanism of the vaults close to the façade, filmed by Umbria Television, resulted from the progressive loss of curvature of the ribs, then a “hinge” was produced in the middle and finally the rib collapsed, drawing the vault down with it (*Figure 28*). A similar mechanism occurred in the zone close to the transept, where the second vault collapsed.

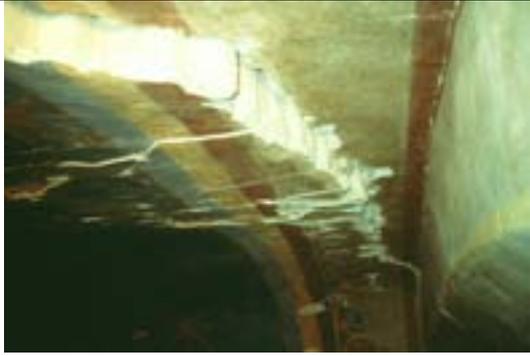
Figure 30: Large cracks with relative movements of around 25 cm

The surviving vaults were all affected by large cracks distributed both on the intrados and the extrados (*Figures 30, 31*); curvature, as already said, was lost in several areas.

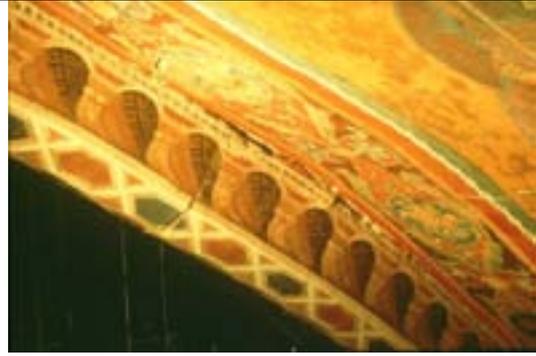
Figure 31: Cracks and detachment between webs and ribs

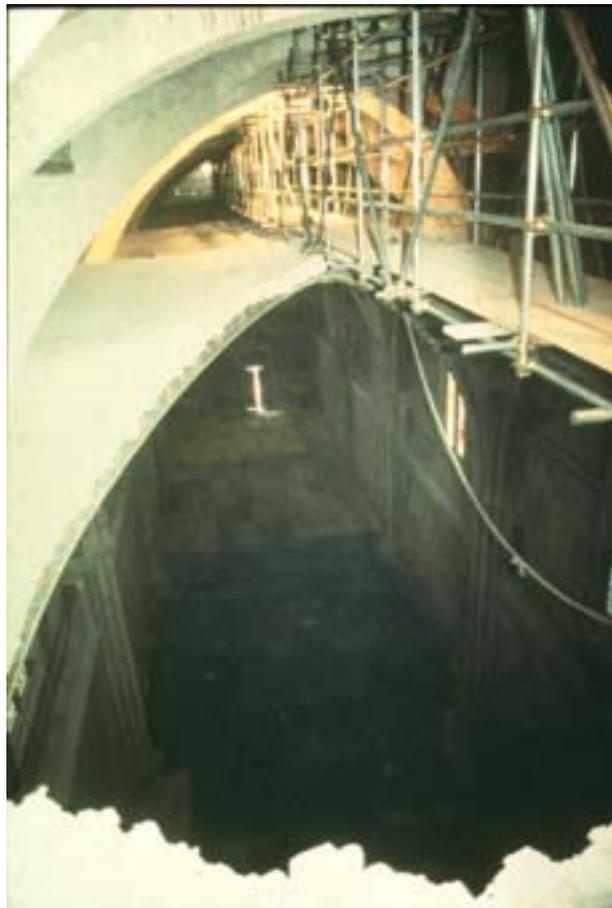
Figure 32 : The little flying bridge suspended to the roof to inspect and strengthen the vaults

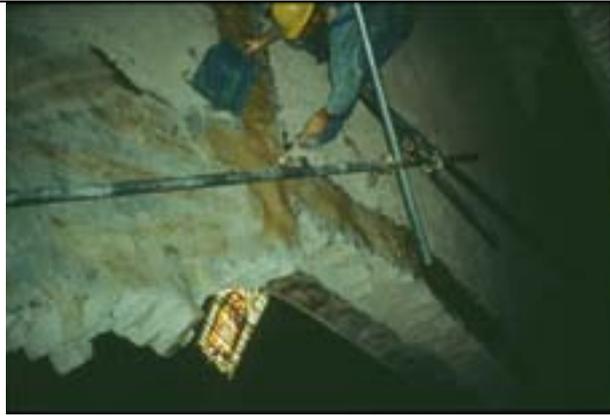
Figure 33: Little synthetic fiber strips applied over the vaults

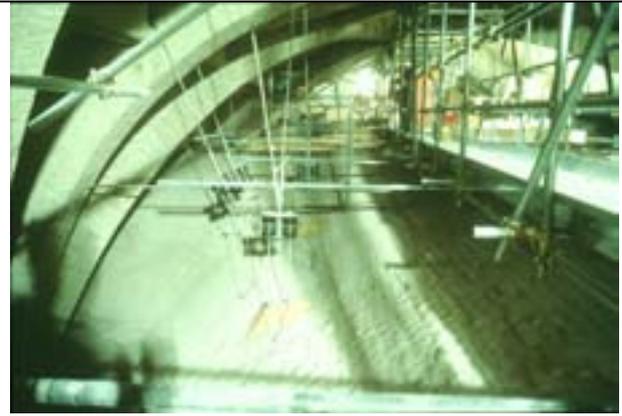
Figure 34: The system of wires and springs to suspend the vaults to the roof

The urgent measures taken in the first month after the main earthquakes were: removing the huge load represented by the fill in the springer zones of the vaults, filling the cracks with a salt free mortar, applying bands of synthetic fibres over the cracks of the extrados (*Figure 33*), suspending the vaults from the roof with a system of tie bars, having first inserted two springs to maintain the force at the design value, independent of thermal effects and minor vibrations (*Figure 34*).

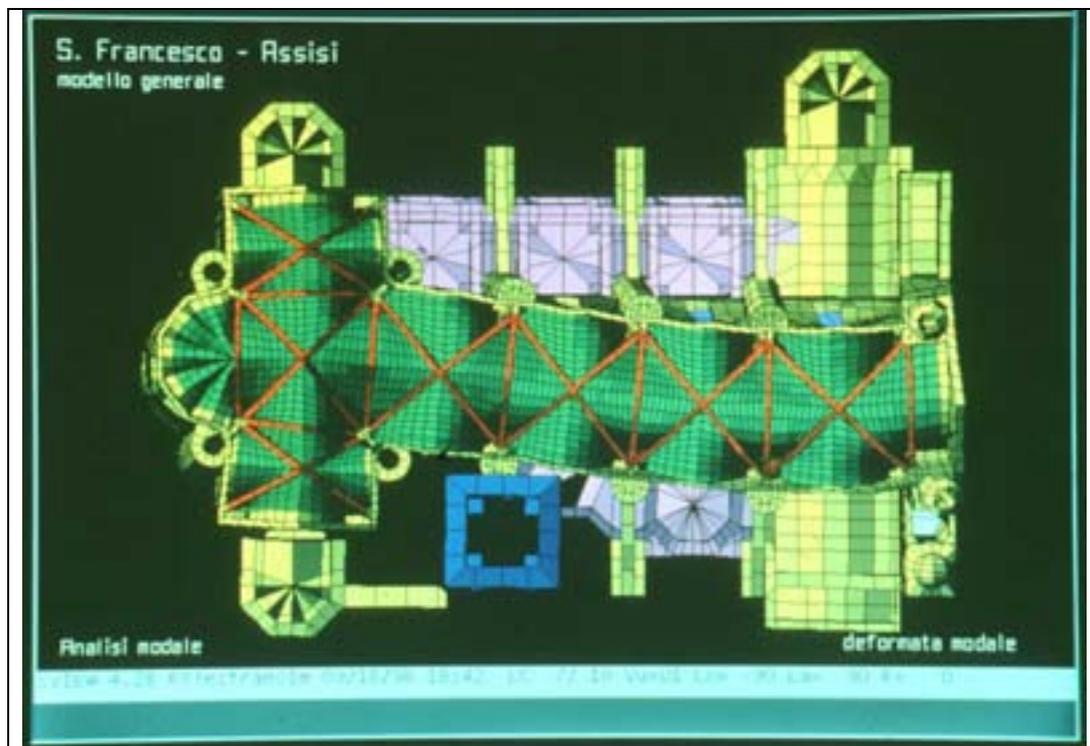
Figure 35: One of the modes of vibration of the global model

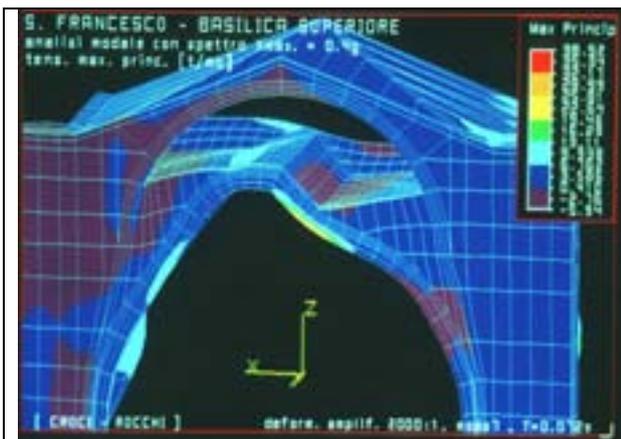
Figure 36: Stresses and deformation of the vault with fill

This model has clearly shown that high tensile stress is produced in the ribs and the curvature is reduced even in static conditions under the effect of dead loads; with horizontal forces between 0.25÷0.3g the vault may collapse (*Figure 36*).

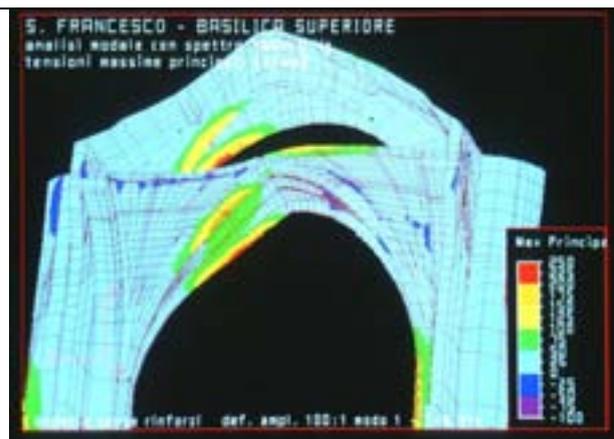
Figure 37 : Stresses and deformation in the vaults without fill

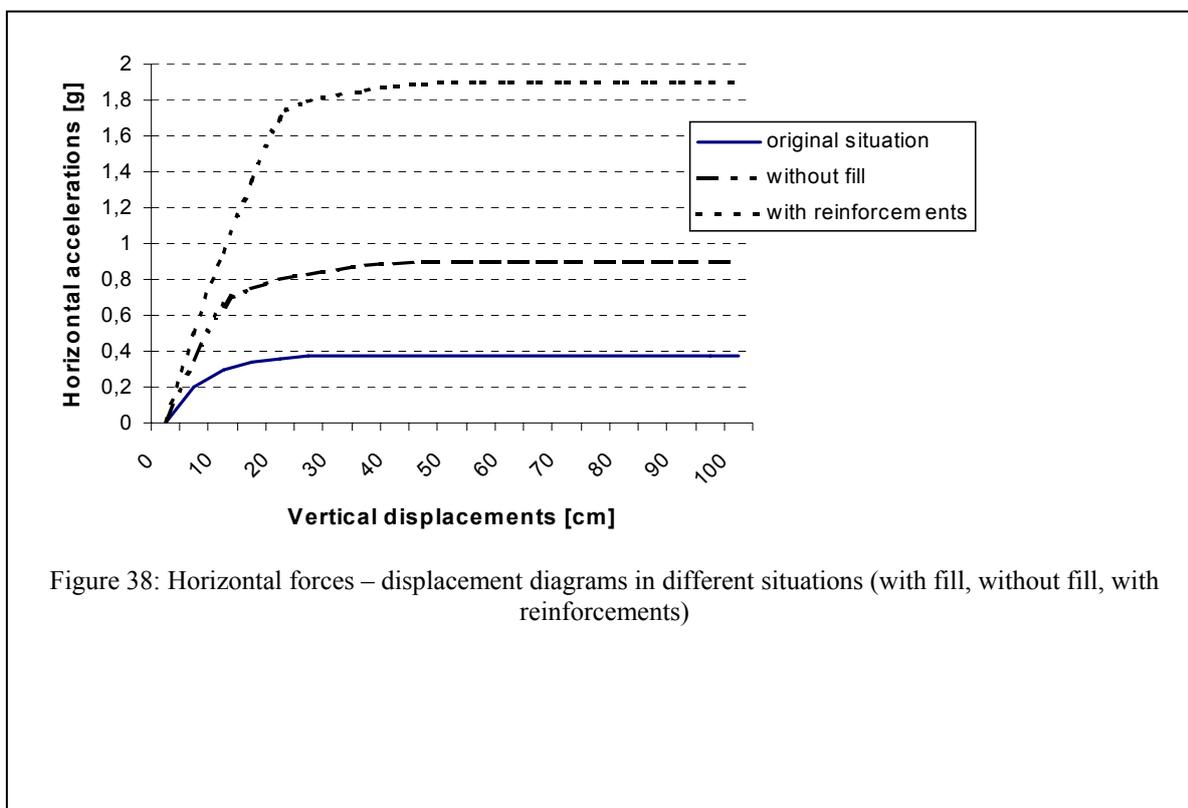
Figure 38: Horizontal forces – displacement diagrams in different situations (with fill, without fill, with reinforcements)

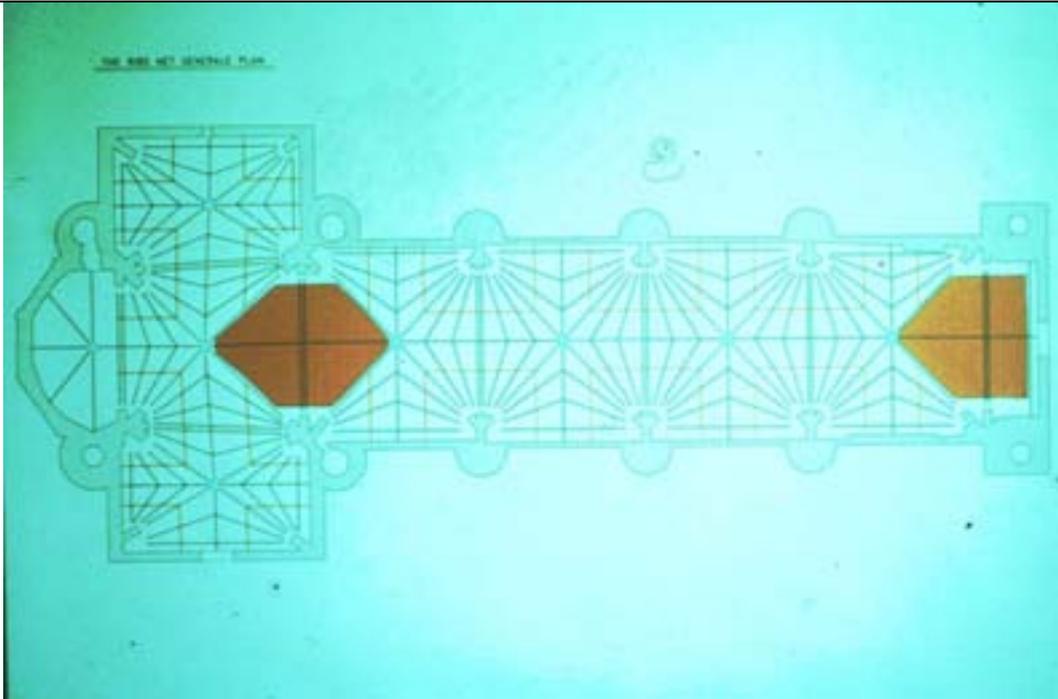
Figure 39 : The pattern followed by the new ribs placed on the extrados of the damaged vaults

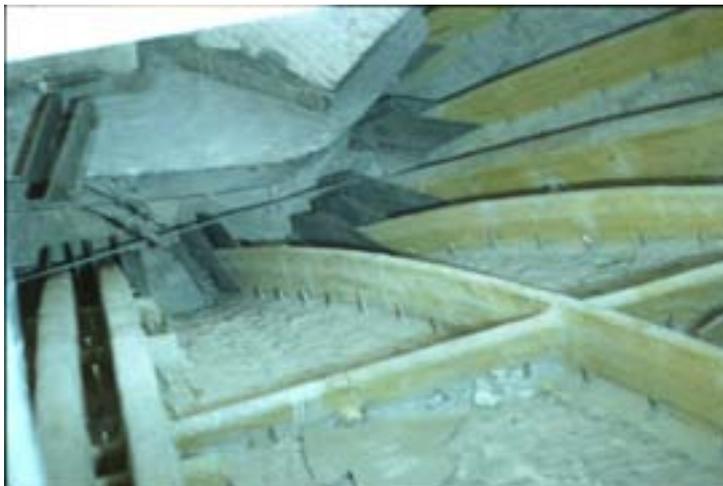
Figure 40: The ribs covered with aramidic fiber tissue

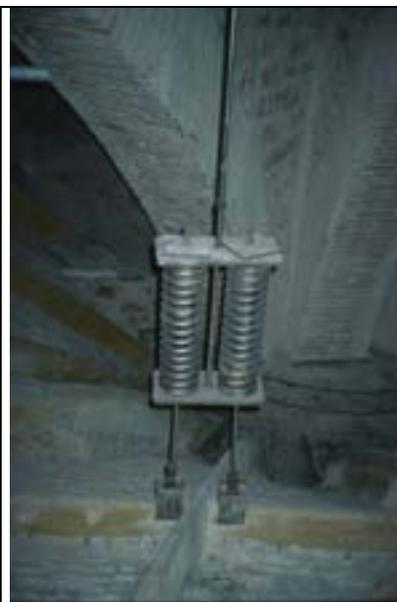
Figure 41: The tie bars and springs which connect the ribs to the roof

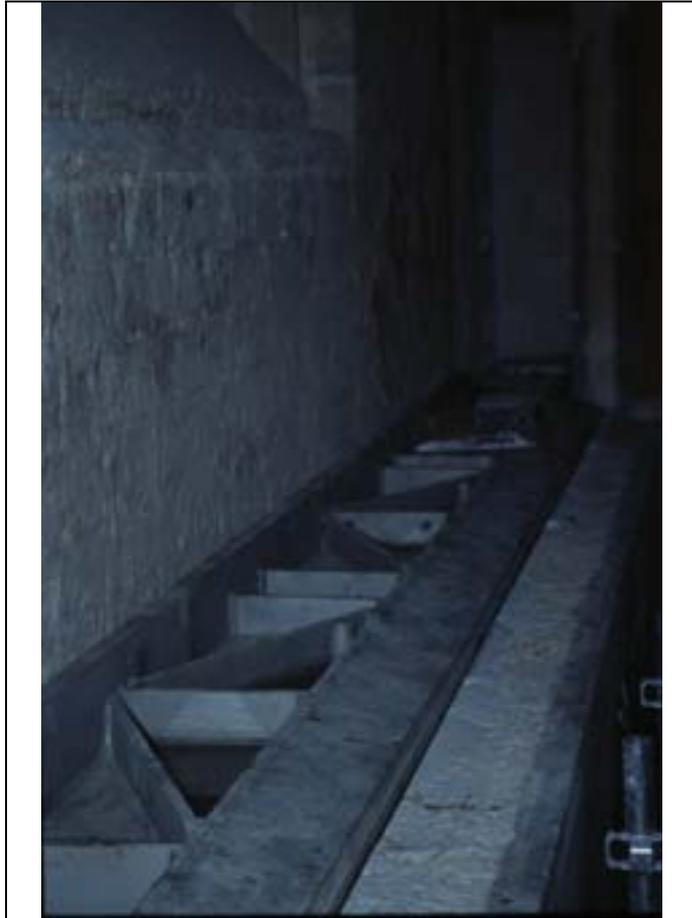
Figure 42 : The trussed steel beams placed over the cornice
inside the Basilica

To limit this phenomenon, a horizontal steel trussed beam has been placed over the cornice of the walls inside the Basilica (immediately below the stained glass windows), to stiffen and strengthen the walls covered with Giotto's frescoes. The connection between this beam, which runs along the perimeter, and the walls has been created with special viscous devices which allow relative displacements due to thermal effects, but become rigid under dynamic forces and provide full strength in the event of earthquakes (shock transmitter) (Figure 42).
